The Remington – Make-up Air Unit Electrification Retrofit Case study

PREPARED BY: FRESCo

Building Name/Address	The Remington, 3528 Vanness Ave, Vancouver
Building's Asset Class	Multi-Unit Residential (MURB)
Building Size	~5,760 sq.m (~62,000 sq.ft.)
Year Built	1999
Building Owner & Manager	Concert Properties / Concert Realty Services
Engineering & Mechanical Consultant	FRESCo

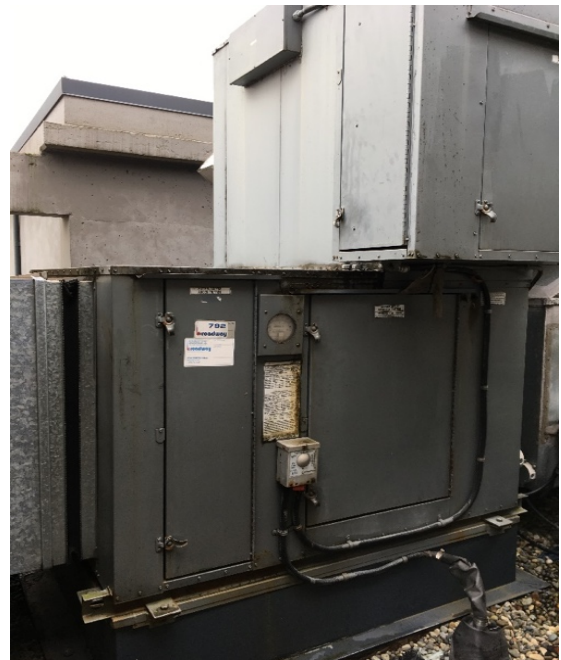
An energy study, commissioned by Concert, revealed the building's existing makeup air (MUA) system was at the end of its useful lifespan. The MUA system delivers tempered outdoor air to the common areas of the building, such as the hallways, to pressurize them and mitigate against odour and smoke migration.

Figure 1 Original MUA unit - low efficiency natural gas

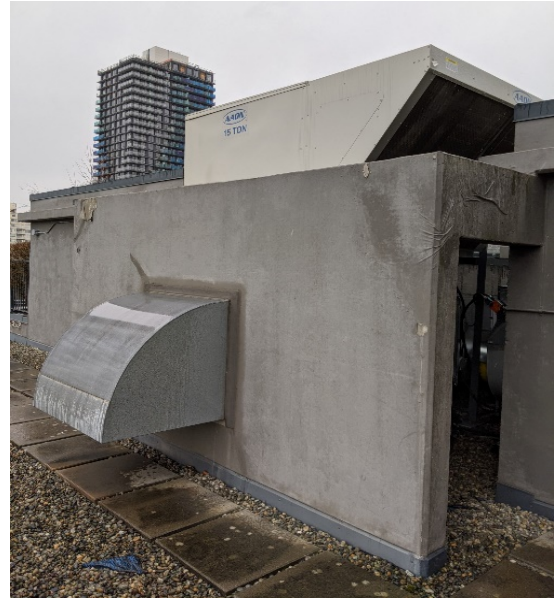
Figure 2 New MUA unit – heat pump w/ electric back up

A second challenge encountered was incomplete system commissioning. During the engineers' final review, the MUA unit was functional but relying on the back-up heat source instead of the heat pump due to incorrect control settings. Additionally, the control and monitoring point connections to the Building Automation System had not been completed. The controls contractor had to be re-engaged to address and reprogram sequence of operations of the BAS.

Another challenge was a noise complaint from one or two tenants in the adjoining tower to the Remington building. After a thorough investigation by an acoustical consultant it was found that, although the added sound from the new heat pump was only marginally higher than the ambient background noise, it would be prudent to install the manufacturer's sound reduction kit to appease the tenants. This installation was done under a separate, subsequent contract.
