Lunch and Learn Overview

- Hazardous Building Materials (HBM)
 - Regulatory Requirements
 - Common Asbestos-Containing Building Materials
 - Lead Paint, Mercury and PCBs issues
 - Management Strategies for hazardous materials
 - HBM Abatement, what does it look like?
- Mould and Water Damage
 - Building Materials Commonly Impacted by Mould
 - Water Damage Due Diligence
 - Restoration Review and Oversight
- Building Science Investigations
 - Leak investigation following water ingress
 - Repair of water ingress to prevent future mould growth
 - Preventing water ingress through proactive inspection
- Project Case Studies

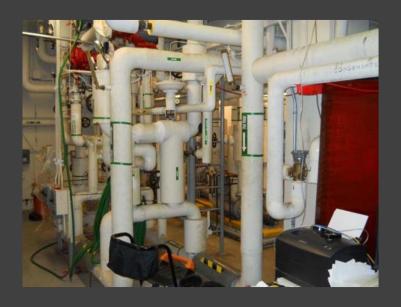
Pipe Insulation

Friable Materials

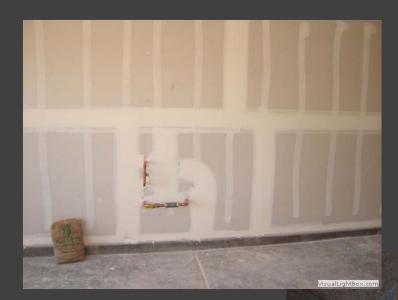
Drywall

Non-Friable Materials

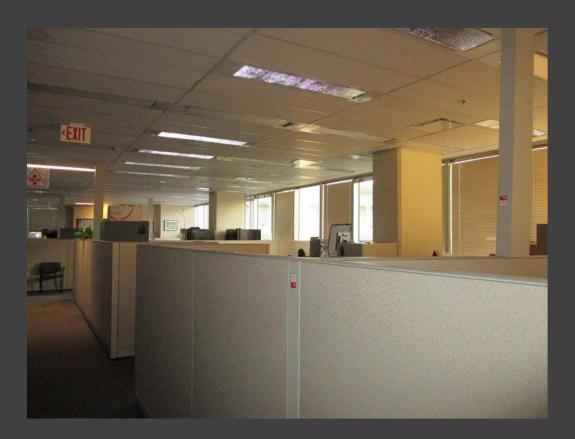
Demo Drawing Provided by Client

Renovation of an office building to accommodate a new tenant.

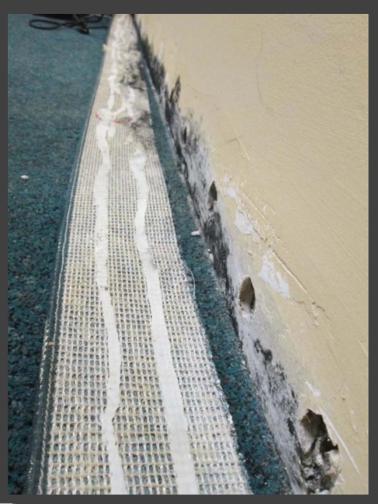
Mould growth identified on asbestoscontaining drywall at exterior wall in a commercial building by occupants.

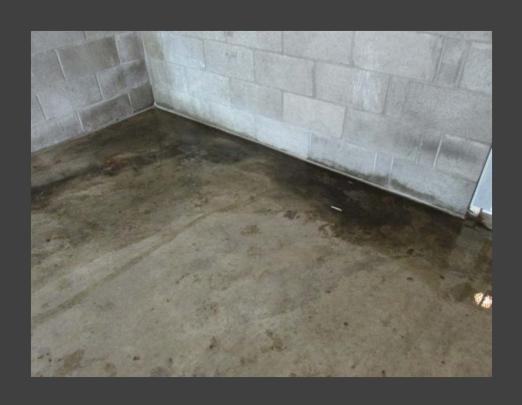
Root cause
 determined to be
 water ingress
 from poor
 drainage from
 alley parking area.

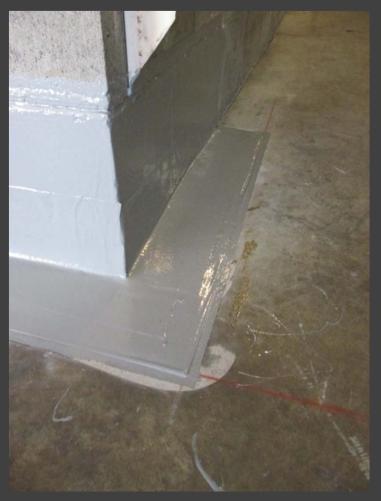
Water proofing membrane installed to redirect water away from the wall.

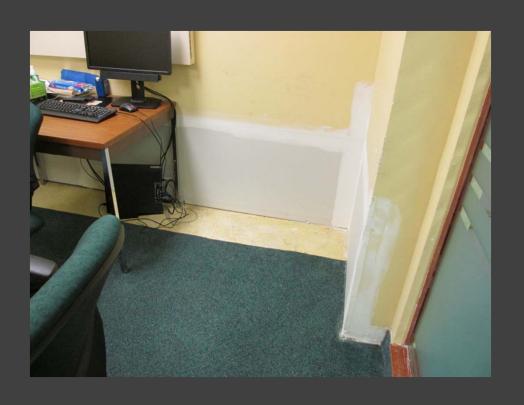
Interior building materials reinstated, ready for paint, following verification of membrane effectiveness.

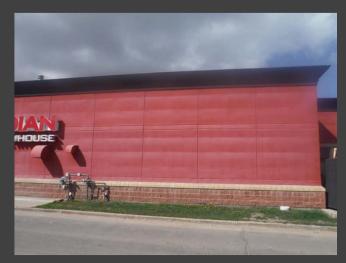
- Example of failed Exterior Insulation Finishing System (EIFS) cladding
- Poor architectural detailing
- EIFS application too thin; resulting in cracking

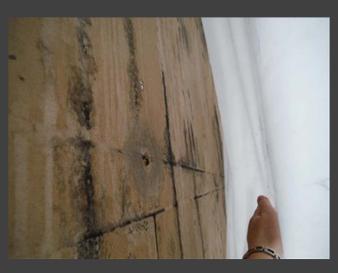
- Mould developed due to water ingress through EIFS
- Exterior GWB
 susceptible to water
 damage (paper faced)
- New GWB resistant to water damage (FG)
