Evergreen Community Health Centre – Make-up Air Unit Electrification Retrofit Case study

PREPARED BY: FRESCo

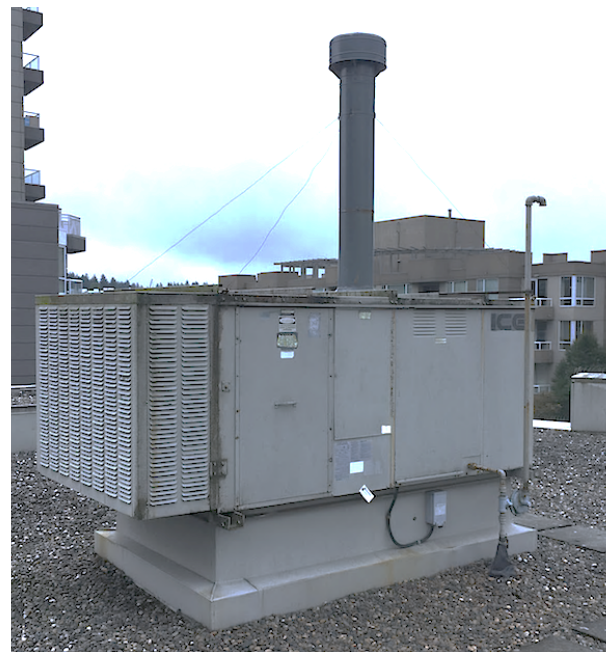
An energy study, commissioned by Concert, revealed the building's existing makeup air (MUA) system was at the end of its useful lifespan. The MUA system delivers tempered outdoor air to the plenum space in all three floors, P1 and P2. At the main three floors, air is then taken in by the plenum mounted heat pumps, conditioned and distributed to different spaces within the building.

Figure 1 Original MUA unit - low efficiency natural gas

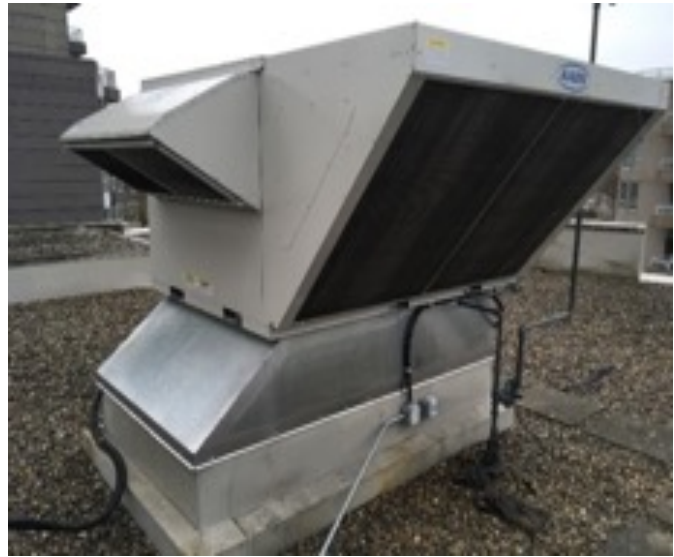
Figure 2: New MUA unit – heat pump with gas backup

Gas-fired backup heating was selected for this project since there was a concern with existing utility service capacity for a full electrification project. Electric resistance for backup heating requires 2 to 3 times the electrical power as the heat pump compressors.

A second challenge encountered was incomplete system commissioning. During the engineers' final review, the MUA unit was functional but relying on the back-up heat source instead of the heat pump due to incorrect control settings. Additionally, the control and monitoring point connections to the Building Automation System had not been completed.
